SUBJECT: Technical Report of U.S. Army Accident

1. Enclosed is the Aircraft Accident Report required by AR 385-10 for the accident involving a Joint Land Elevated Netted Sensor Aerostat that occurred at Aberdeen, MD, on 28 October 2015. There are two copies of the report, one for retention at the unit and one for submission through the ACOM/ASCC/DRU commander to the U.S. Army Combat Readiness Center (USACRC).

TECHNICAL REPORT OF U.S. ARMY AIRCRAFT ACCIDENT INDEX B For use of this form, see DA Pamphlet 385-40; the proponent agency is OCSA.					REQUIREMENTS CONTROL SYMBOL CSOCS-309

1. MISSION, TYPE, DESIGN, AND SERIES JLENS Aerostat		2. CASE NO.		a. Date (YYYYMMDD) 20151028	b. Time 1147	c. Acft Serial No. 74M002		
3. TAB	Title				DA Form No.	Encl	Not Appl	See Remarks

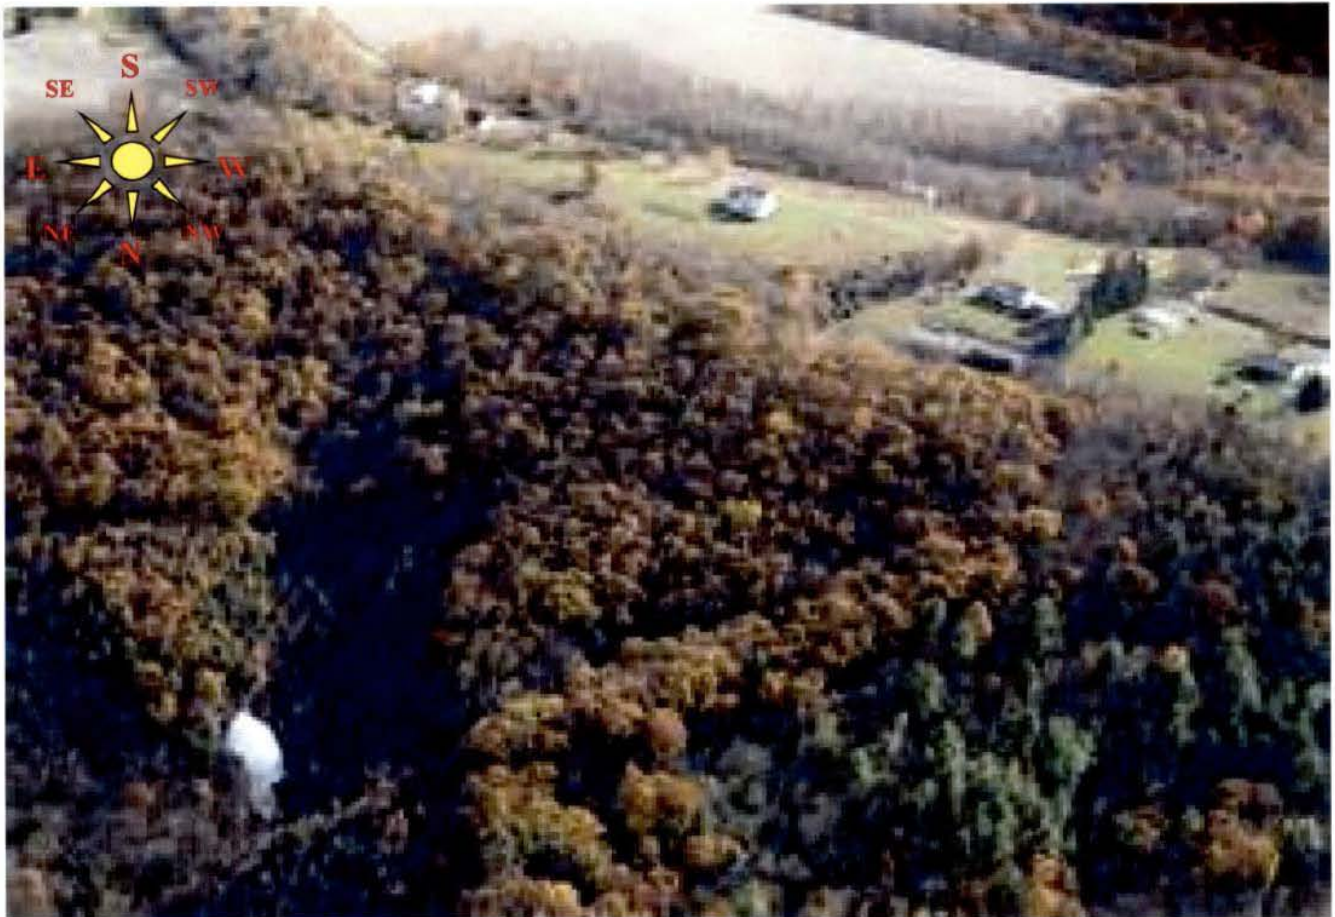
Aerostat in hollow

h. Crash Site Information. The aerostat parts were in two places. The first impact was at (b)(6) at the edge of a field in the trees. The aerostat continued to move northwest down a stream feed hollow to a secondary hollow where the mooring lines and tether cause the aerostat to halt. No roads were available to the aerostats final resting point. All access to the aerostat was by foot, through difficult terrain, until the second day, when the land

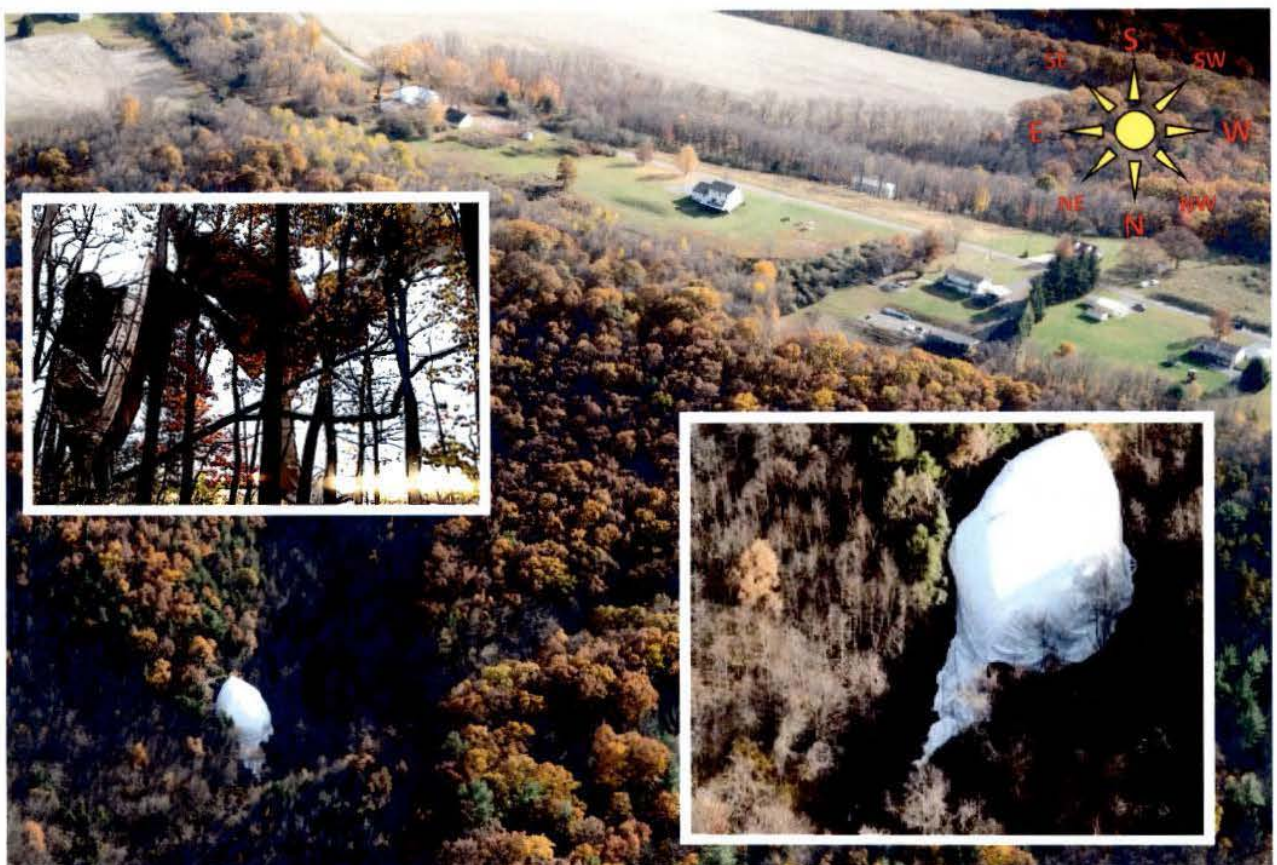
Photo -- 74 Meter Aerostat, 74M002, Edgewood, MD, 28 October 2015

Final resting place of aerostat pieces.

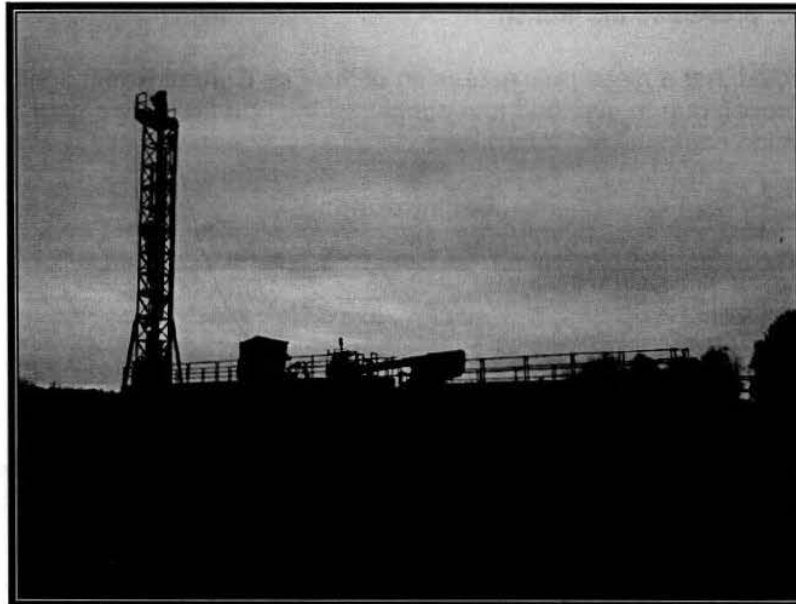
Photo 1, Mobile Mooring Station, S/N 74M001

3. TCOM, L.P. records indicate the mobile mooring station (MMS), TCOM P/N 4D00002G01, S/N 74M001, entered service on 14 June 2010 (Photo 1). The MMS transferred directly from DPG UTTR to APG.

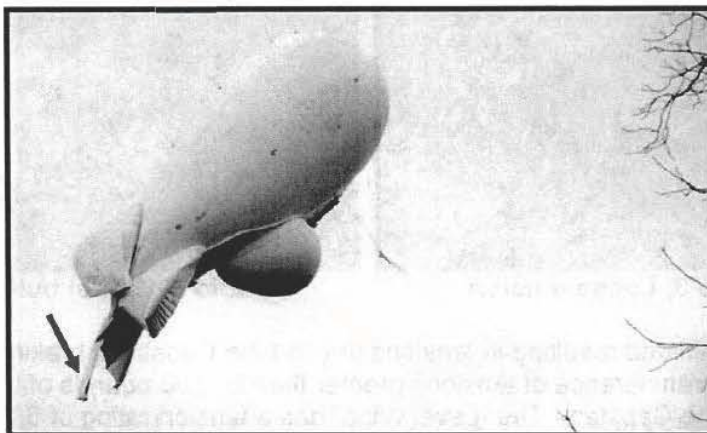
Photo 2, Port fin tear

1. Aerostat fabric was analyzed by Natick Labs, Raytheon, and TCOM. Fabric was analyzed against the strain and stress numbers of the original fabric verses a fabric which has been in the operational environment. Testing was performed at Elizabeth City.
2. The aerostat hull was laid out in sections and the damage was mapped on engineering drawings. The damage will be referred to as location numbers (LN) found on the drawings. This information was extracted from the information compiled by Natick Labs and TCOM, LP.
3. The port fin was observed at the landing location deflated with a long portion of the trailing edge severed (Photo 2). The tear began at the leading edge and terminated at 13.8 (LN 1). There were two punctures (LN 3, 7), one that penetrated the air inflated spar. Two other spars were ripped and torn (LN 4, 6).¹

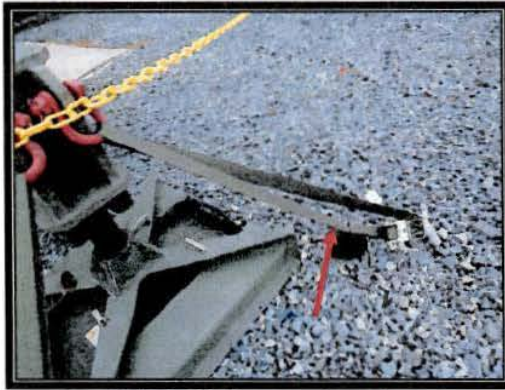
Photo 3, Loose tension

1. Visual inspection revealed the tie down straps were loose (Photo 3) and movement of the outriggers (Photo 4). This was typical at all four outriggers.

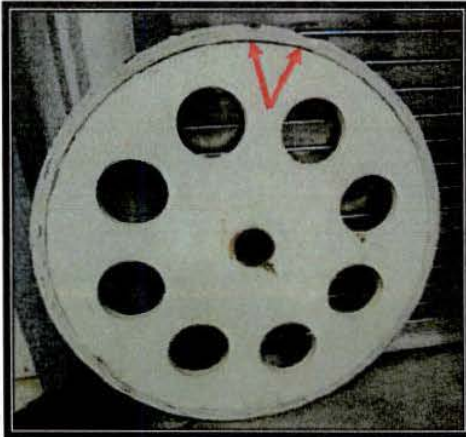
Photo 5, Damaged level wind sheave

2. The port fin deflated resulting in tensions beyond the Capstan's braking capability and allowed the transference of tensions greater than 64,300 pounds of tension to propagate past the Capstan. The "Level Wind" has a tension rating of 5,000 pounds, and an estimated tension of up to 100,000 pounds of tension reached the capstan, translating 40,000 pounds of tension to the level wind resulting in an explosive detachment of the "Level Wind" sheave (Photo 5) from its mounts (Photo 6) that catapulted it into the ceiling of the MMS denting the ½" thick steel support beams in two places forward of its original position. This resulted in the tether being crimped in the tunnel entrance into the capstan module from the Level Wind. The tether continued to out spooled at 18 RPMs and allowed the damaged tether to transit the capstan to the outfeed where it failed.

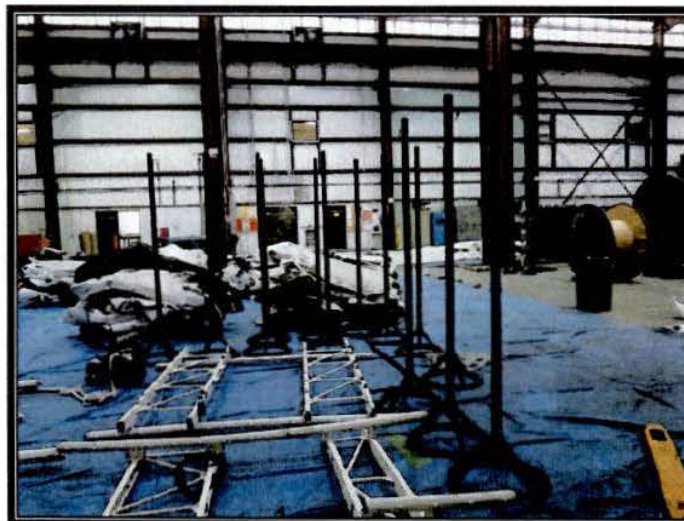
Photo 7, Thirteen standoff poles.

1. All thirteen standoff poles were recovered (Photo 7).

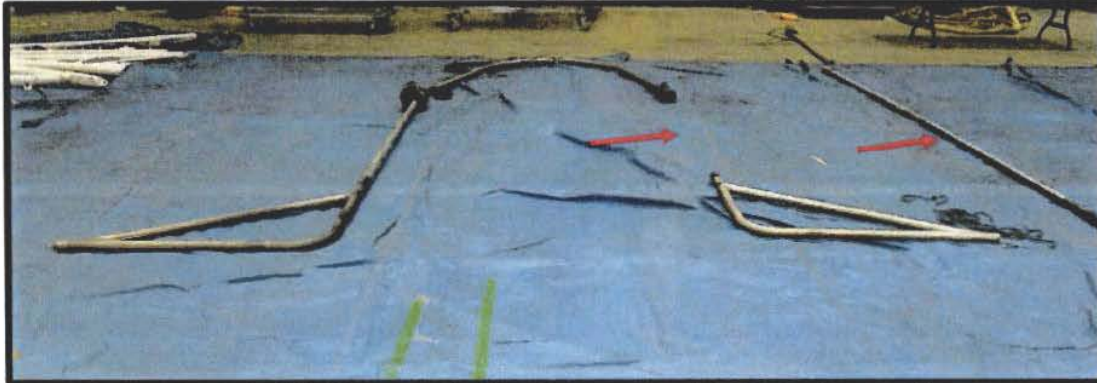
Photo 8, Wishbone missing section, Fin Tip Pole Assembly

2. The "wishbone" was visually inspected with one section missing (Photo 8). The Fin Tip Pole Assembly was visually inspected.

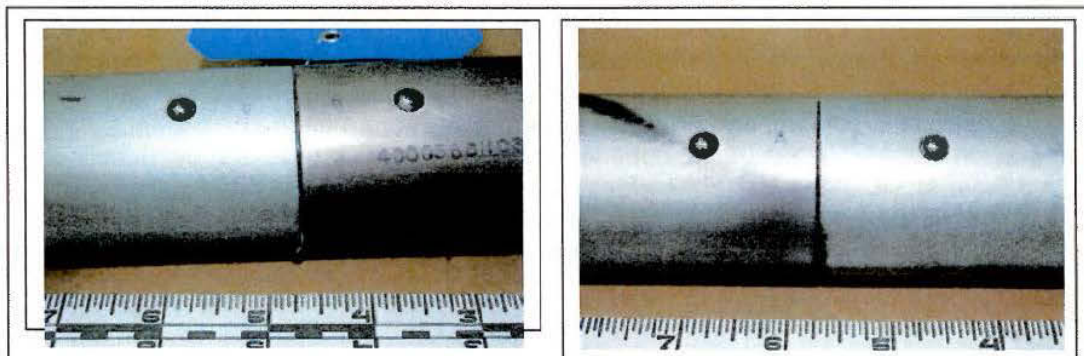
1. Fin tip pole 3 (4D00368H04) was installed inverted to its normal position. The letters marked on fin tip pole joint 1 (4D00368H03) and fin tip pole 3 (4D00368H04) were mismatched (A to B). The letters marked on fin tip pole 3 (4D00368H04) and fin tip joint 2 (4D00368H05) were also mismatched (Figure 1).

Figure 1 – Views showing the mismatched lettering on fin tip pole joint 1 and fin tip pole 3 (top left, shown at ~0.8X). The letters marked on fin tip pole 3 and fin tip joint 2 were also mismatched (top right, shown at ~1X).

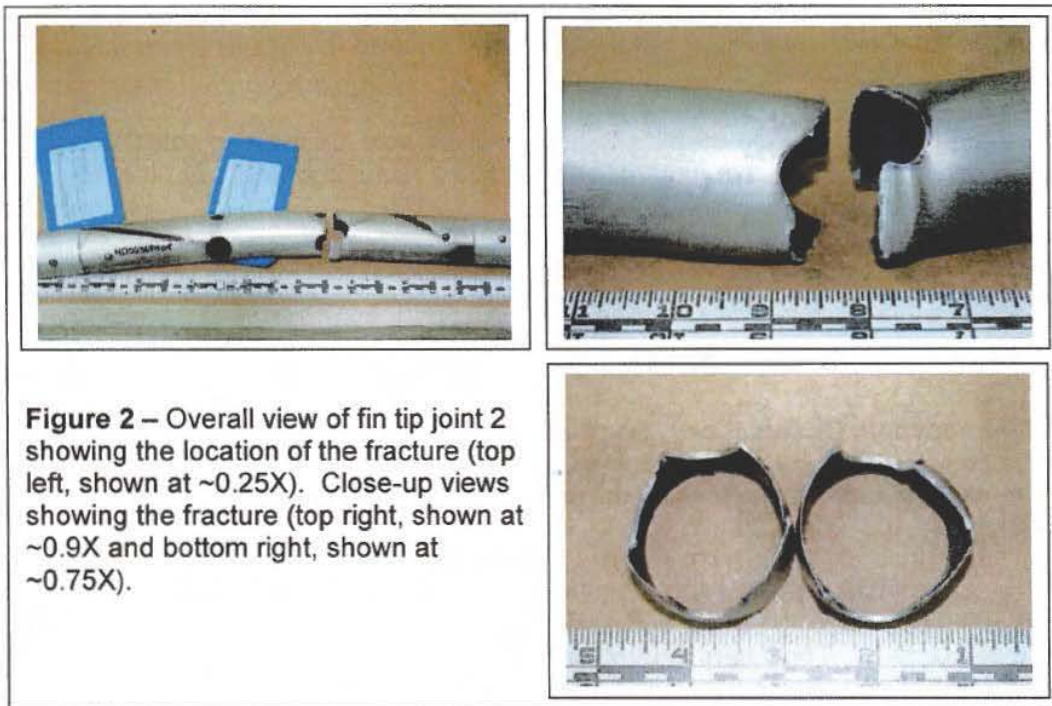
2. A fracture occurred at the right hand bushing of fin tip pole joint 2 (4D00368H05). The fracture surface exhibited features associated with overload failures. Areas of shear lips were present around the entire circumference of the fracture. Areas of rubbing and smearing were also noted on the fracture surface. Buckling of the pole occurred at the terminal end of the failure (Figure 2).

Figure 2 – Overall view of fin tip joint 2 showing the location of the fracture (top left, shown at ~0.25X). Close-up views showing the fracture (top right, shown at ~0.9X and bottom right, shown at ~0.75X).

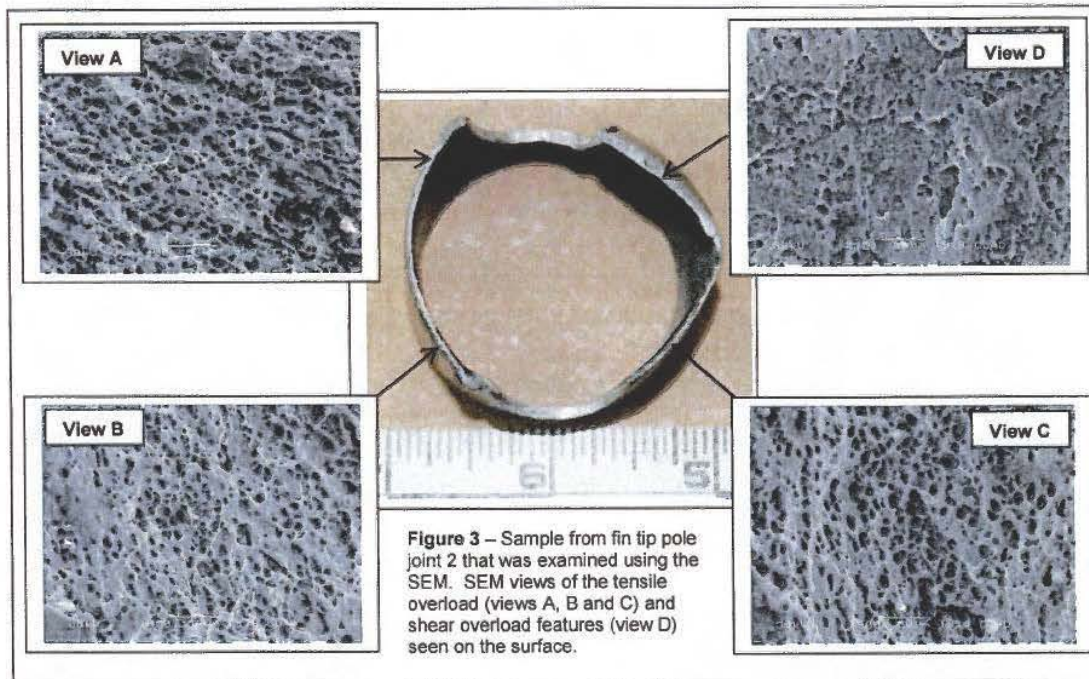
One of the fracture surfaces from the fin tip pole joint 2 was sectioned and prepared for examination using the Scanning Electron Microscope (SEM). The fracture originated from the right hand bushing and progress around and through the pole. SEM examination revealed areas of cup cone topography, indicative of tensile overload, around the majority of the fracture surface. Where the pole buckled and experienced the terminal failure was found to be more of a shear overload (Figure 3). No other anomalies were noted on the fracture surface which might have contributed to the fracture.

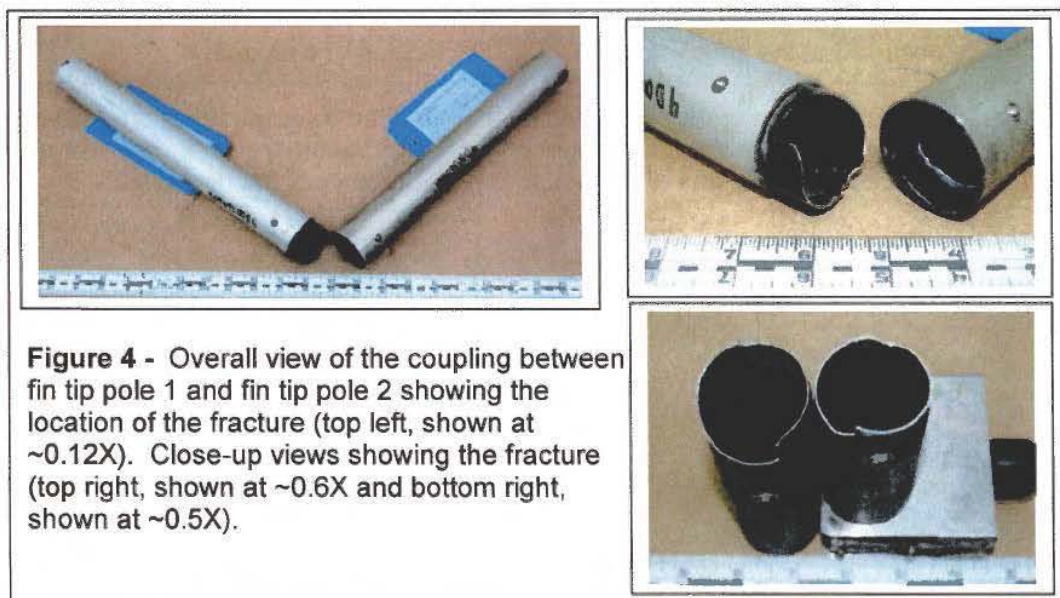
3. A fracture occurred at the coupling (4D00253G01) between fin tip pole 1 (4D00368H01) and fin tip pole 2 (4D00368H02). The fracture surface exhibited shear lips around the entire circumference of the tube (Figure 4). The fracture extended through the weld bead that holds the spring plunger. Discoloration that was present on the fracture surface was determined by Energy Dispersive X-ray (EDX) analysis to be dirt deposits. There were no signs of corrosion around the area of fracture.
